Name Of Dam: LAUREL BED DAM

Location: RUSSELL COUNTY, VIRGINIA

Inventory Number: VA 16701

LEVEL II
PHASE I INSPECTION REPORT
NATIONAL DAM SAFETY PROGRAM

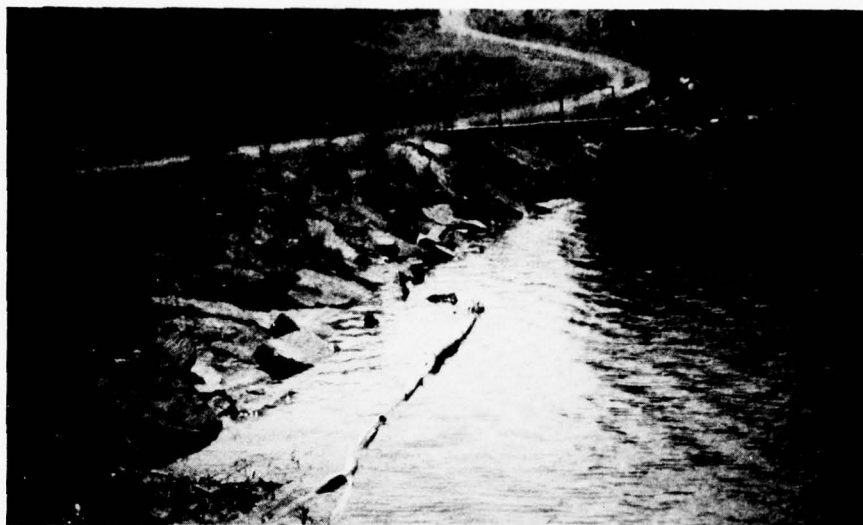
The top width of the embankment is also too narrow according to U.S. Bureau of Reclamation (U.S.B.R.) guidelines (Reference 3). The riprap protection of the upstream slope appears to be deteriorating, but erosion so far has been slight. This condition should be monitored and corrected if it worsens.

UPSTREAM FACE OF DAM SHOWING PRINCIPAL SPILLWAY
AND DETERIORATING RIPRAP

7.2.4 Inspection Program: We recommend that the Owner establish a semi-annual inspection program to monitor the conditions at the dam. Particular attention should be given to monitoring seepage rates and wear of the riprap on the upstream face of the dam.

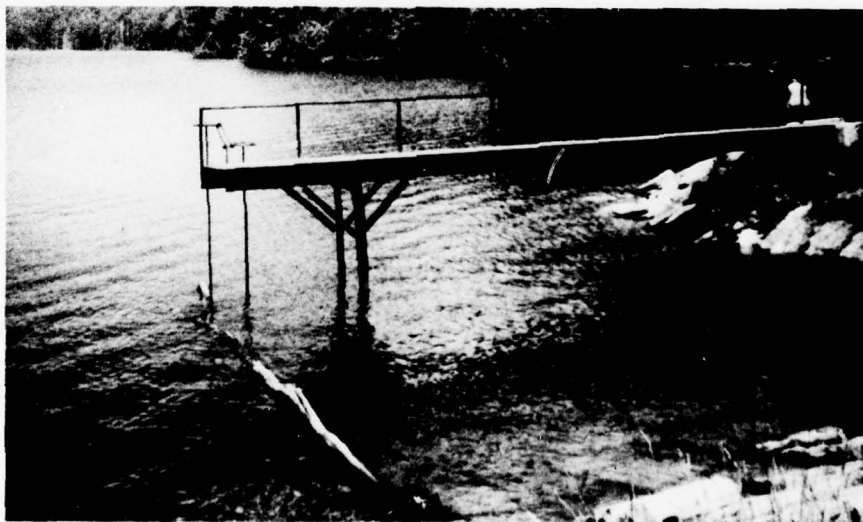
BRIDGE AND CONTROL RODS TO THE TWO 8 INCH
SHALLOW RESERVOIR OUTLETS

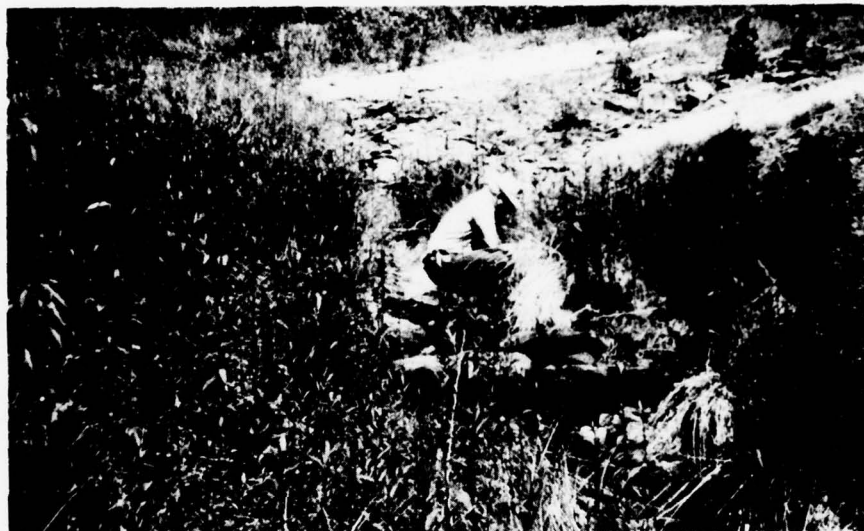
Three seepage areas were observed and are shown on the Plan View in Appendix I. Area 1 is in the emergency spillway channel and Area 2 is on the abutment slope about 70 feet below the dam crest. Although the seepage in areas 1 and 2 appeared to be from the same source, the temperature of the water in the spillway was 49°F and that on the adjacent abutment slope was 56°F. The seepage was estimated at 30 g.p.m. in the spillway and at 4 g.p.m. on the slope. The water was clear in both locations, but the larger flow in area 1 is causing some erosion in the spillway chute. Area 3 was the smallest area with a flow estimated at 1 to 2 g.p.m. It is located near the toe of the dam on the right abutment.

VIEW FROM EMERGENCY SPILLWAY CHUTE LOOKING
UPSTREAM AT EROSION AND SPRING AREA.

7.2.3 Spillway Redesign: The emergency spillway should be protected against erosion. It is recommended that the owner enlist the services of a consultant to design a paving material for the spillway crest which will resist erosion. The emergency spillway capacity was not found to be "seriously inadequate", but future consideration should be given to enlarging it in order to meet the PMF design flood criteria. This work should be carried out in conjunction with the recommendations in Section 7.2.2.
